CORROSION OF A193 GRADE B7 BOLT MATERIAL IN BWR SODIUM PENTABORATE SOLUTIONS

STP-NU-068

S. G. Sawochka
M. R. Miller
M. A. Leonard

Date of Issuance: March 14, 2014

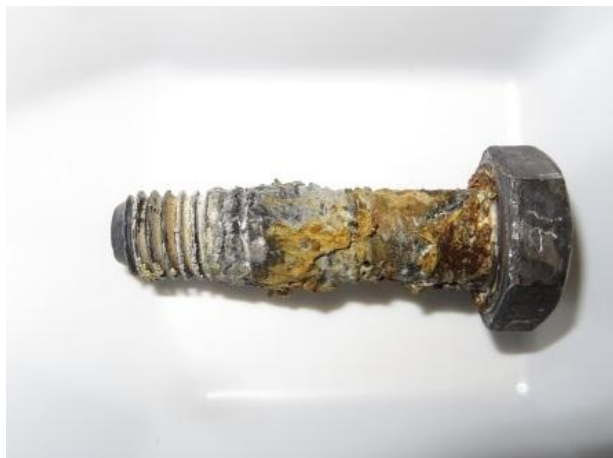
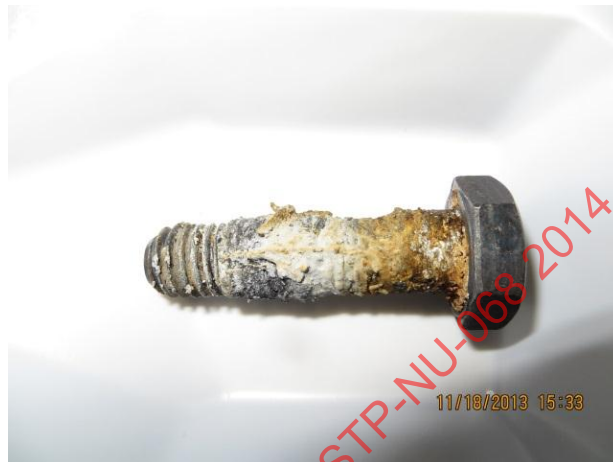
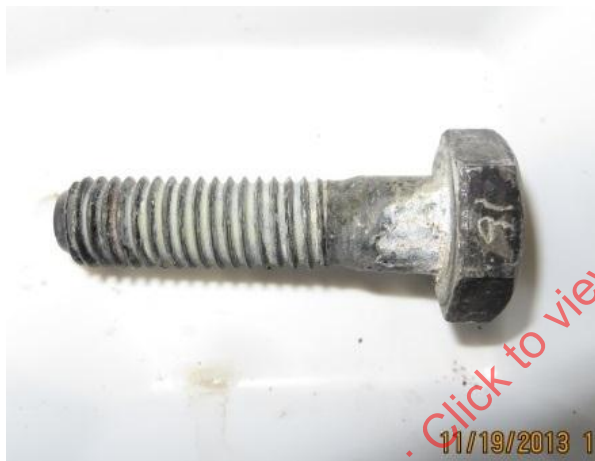
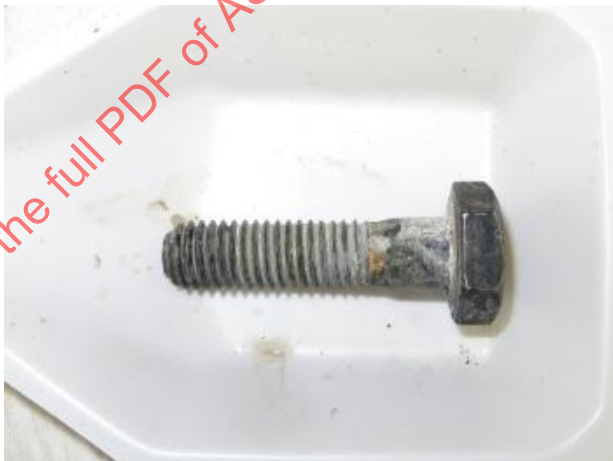
Figure 4-15: Bolt 16 before and after Initial Deposit Removal

Pictures of the bolts before and after attempts to remove the deposits by rinsing and chasing the threads are presented in Figure 4-12 to Figure 4-15. As shown, white deposits were still observed between the threads on all four bolts. Bolts were then scrubbed with a wire brush under flowing hot tap water, soaked in demineralized water and placed in an ultrasonic bath for five minutes. This process effectively removed the deposits, and there was no visual indication of residual deposits or metal oxide. The bolts were then dried and reweighed.

Since there was evidence of localized corrosion in the shank region of Bolts 13 and 16, and the metal loss indicated that there should be a measurable decrease in the shank diameter of these bolts if corrosion was primarily in the shank region and threaded region above the nut, measurements of the shank diameter for all of the flange bolts including three new bolts were made at two locations around the bolt circumference (offset by 90°). Results are given in Table 4-3. As shown, there was a decrease of 0.004 to 0.005 inches in the shank diameter of Bolt 13 at the location of the simulated leak. This bolt had the largest weight loss (1.038 grams) during the test at 203°F. The observed diameter decrease is in reasonable agreement with the values of 0.004 to 0.007 inches estimated from the weight loss data. The diameter decrease for Bolt 16 also is in reasonable agreement with the estimated corrosion rates. No quantifiable decrease in shank diameter was observed for any of the bolts exposed at 95°F which is consistent with the weight loss observations.

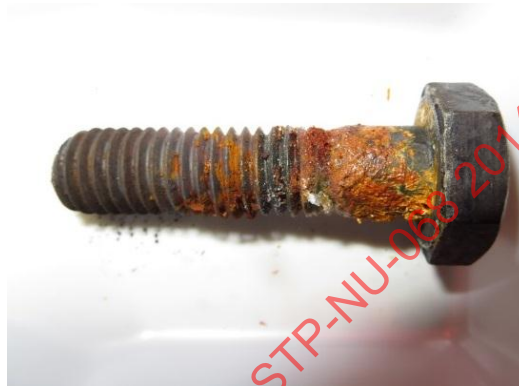
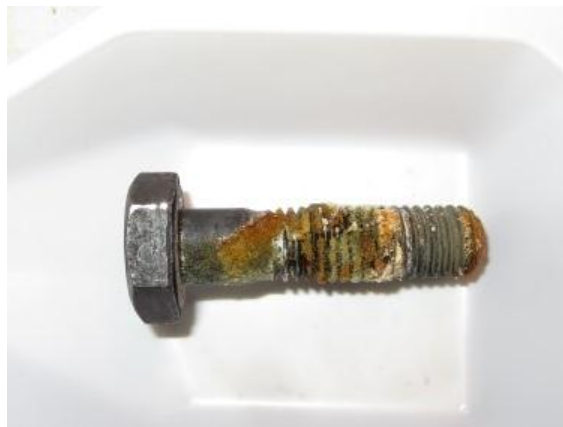
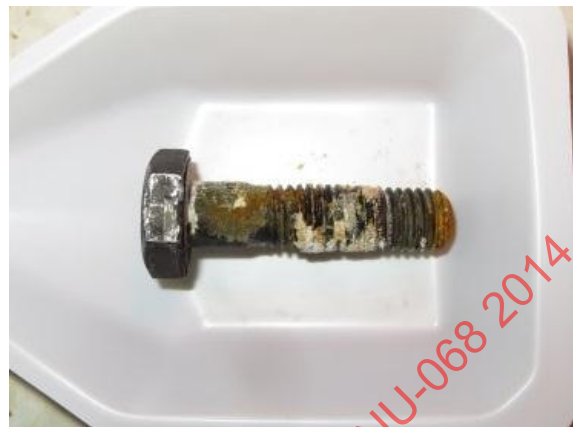
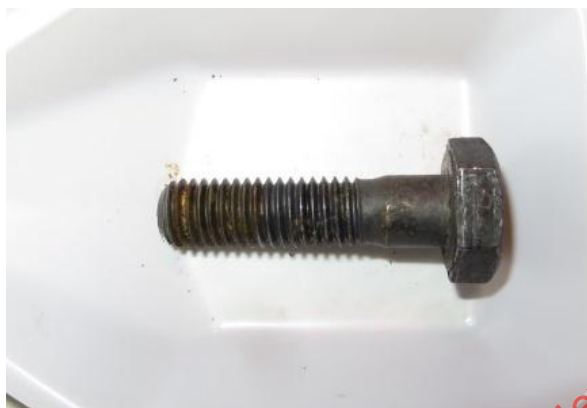
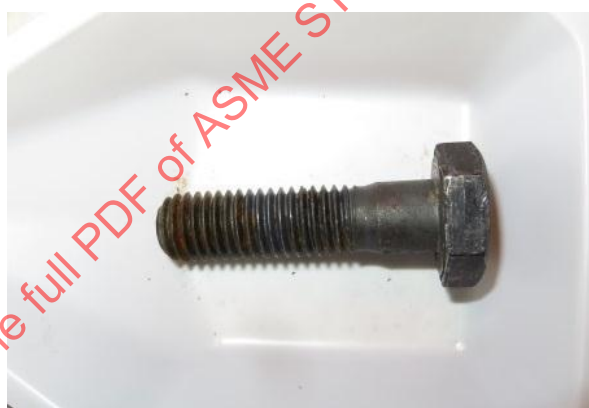
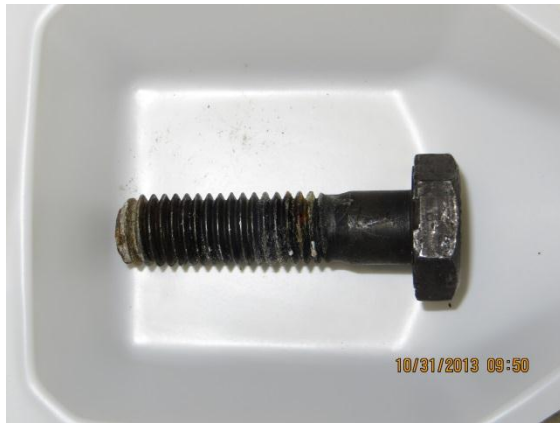
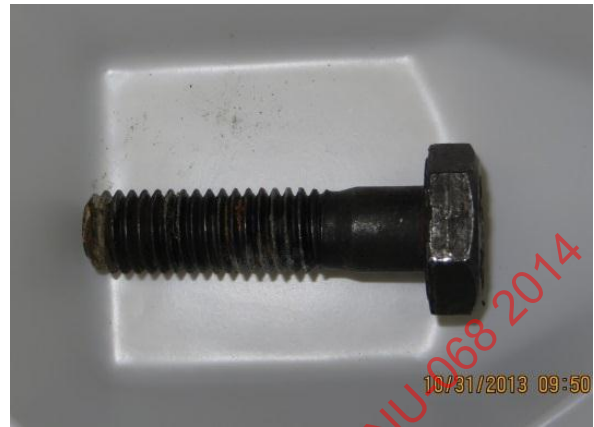
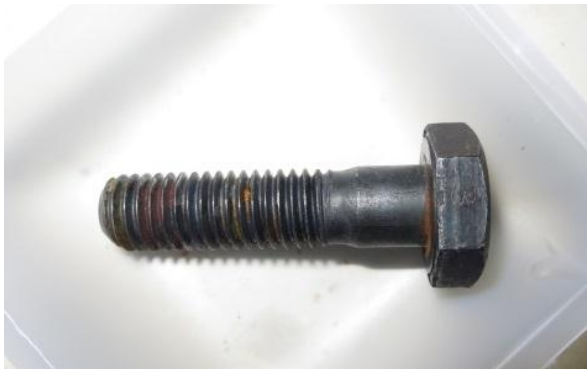
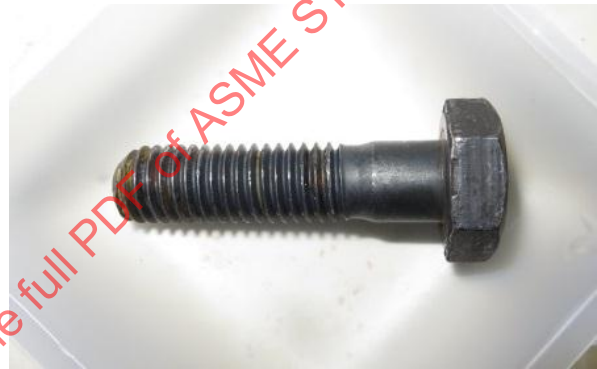
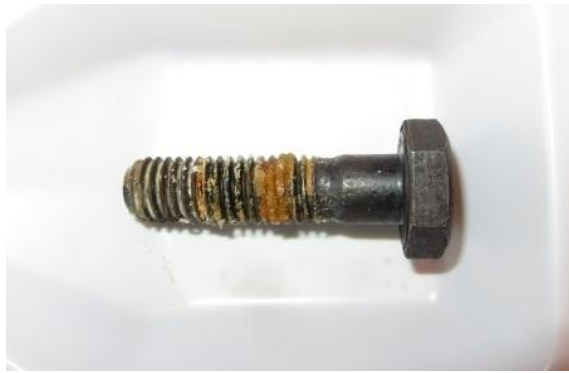
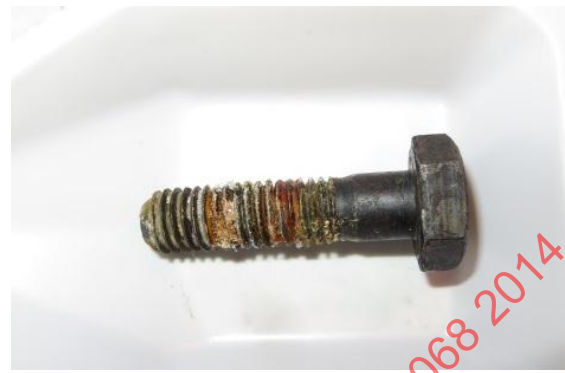
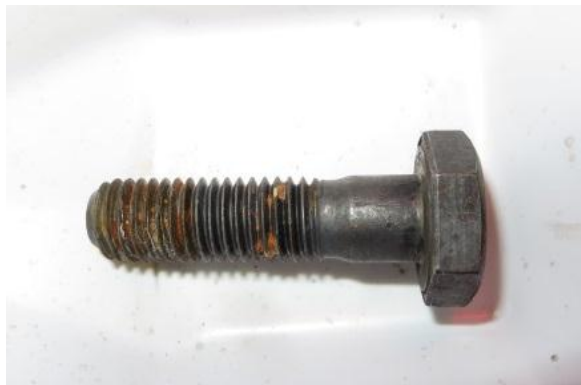
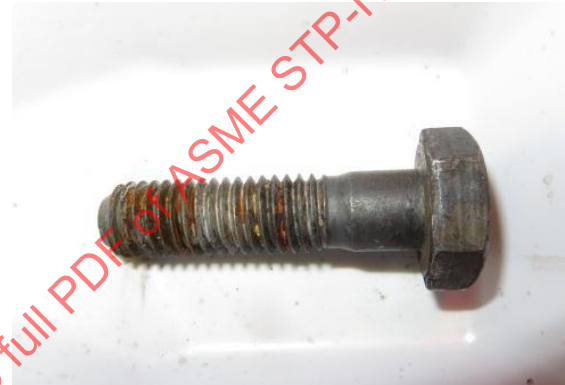
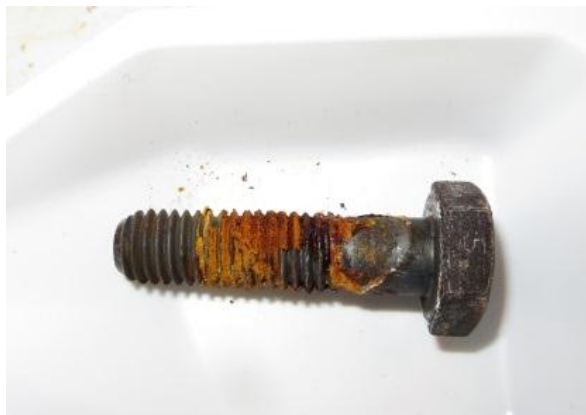
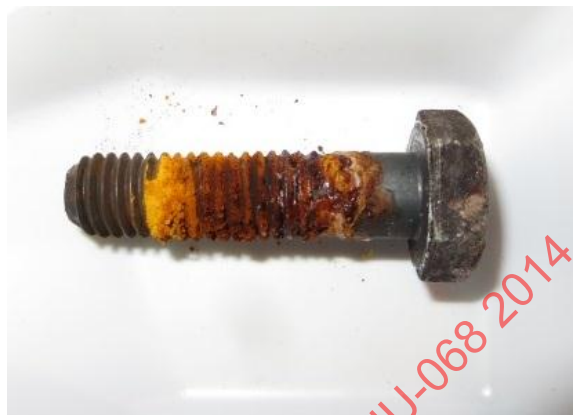
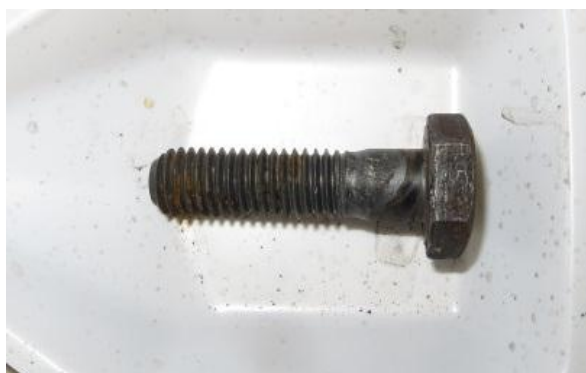
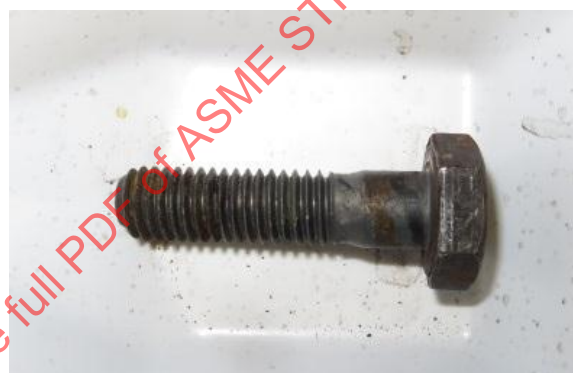
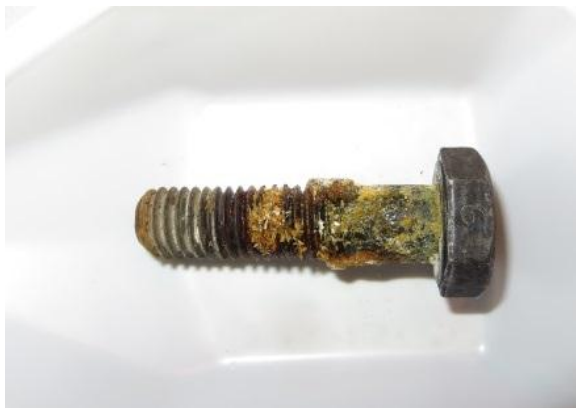
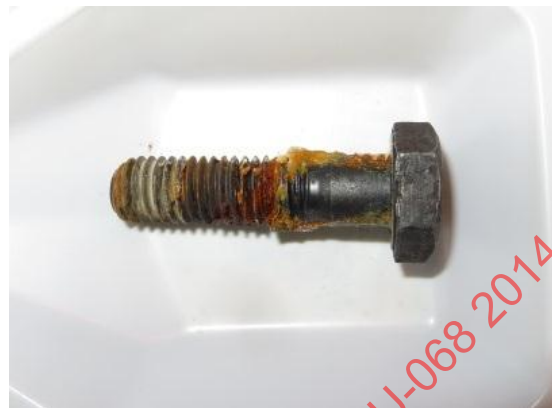
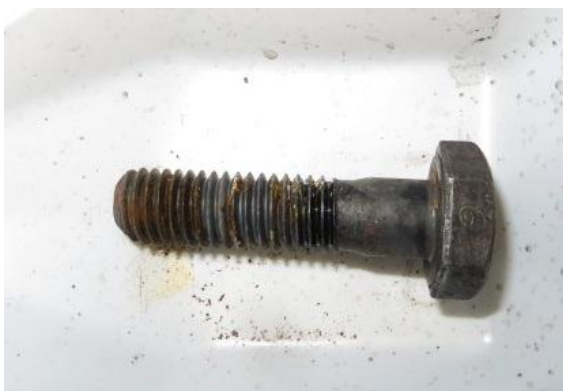
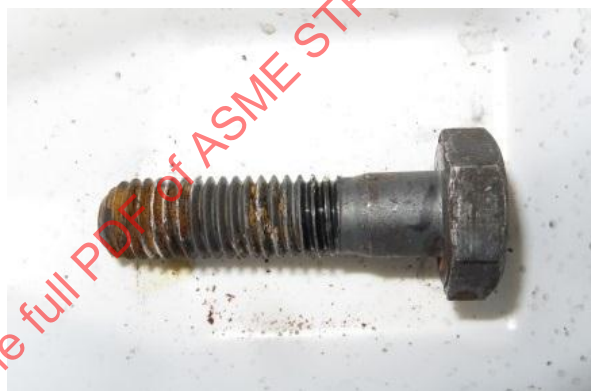
APPENDIX B: Low Temperature Test Photographs

Pictures of the bolts before and after removal of deposits are given in Appendix B. Although a rust colored deposit was generally observed on all bolts following removal, there was no visual indication of local corrosion attack on any of the bolts after they were soaked in 2.5% NaPB solution at room temperature to dissolve readily soluble salts, dried, rinsed, brushed with a soft bristle brush, and dried before final reweighing.
