CORROSION OF A193 GRADE B7 BOLT MATERIAL IN BWR SODIUM PENTABORATE SOLUTIONS

STP-NU-068

S. G. Sawochka
M. R. Miller
M. A. Leonard

Date of Issuance: March 14, 2014

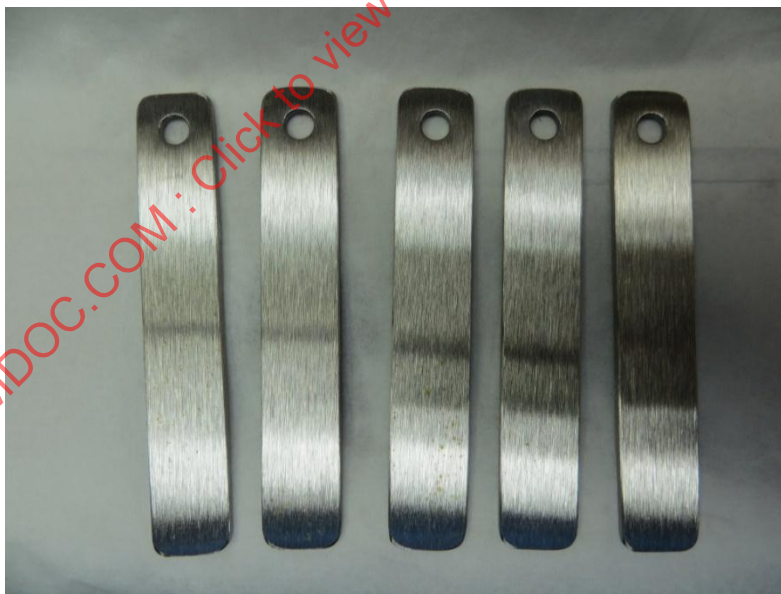
**Figure 3-3: C4140 Test Coupons 7, 8, 9 and 10 (Back Face)
After 20 Days of Exposure and Un-exposed Coupon 11**

The condition of the C1010 test coupons (Numbers 1 to 4) is compared to that of an un-exposed C1010 coupon (Number 7) in Figure 3-1. Very limited indications of localized corrosion are present near the bottom of Coupon 1. Condition of the C4140 test coupons (Numbers 7 to 10) is compared to that of an un-exposed C4140 coupon (Number 11) in Figure 3-2 Figure 3-3. The only visually observable corrosion of the C4140 material was on Coupons 8 and 10. Coupon 10 exhibited small localized regions of oxide formation on the front side of the coupon. Coupon 8 exhibited more limited localized corrosion on the lower end of the back side of the coupon.

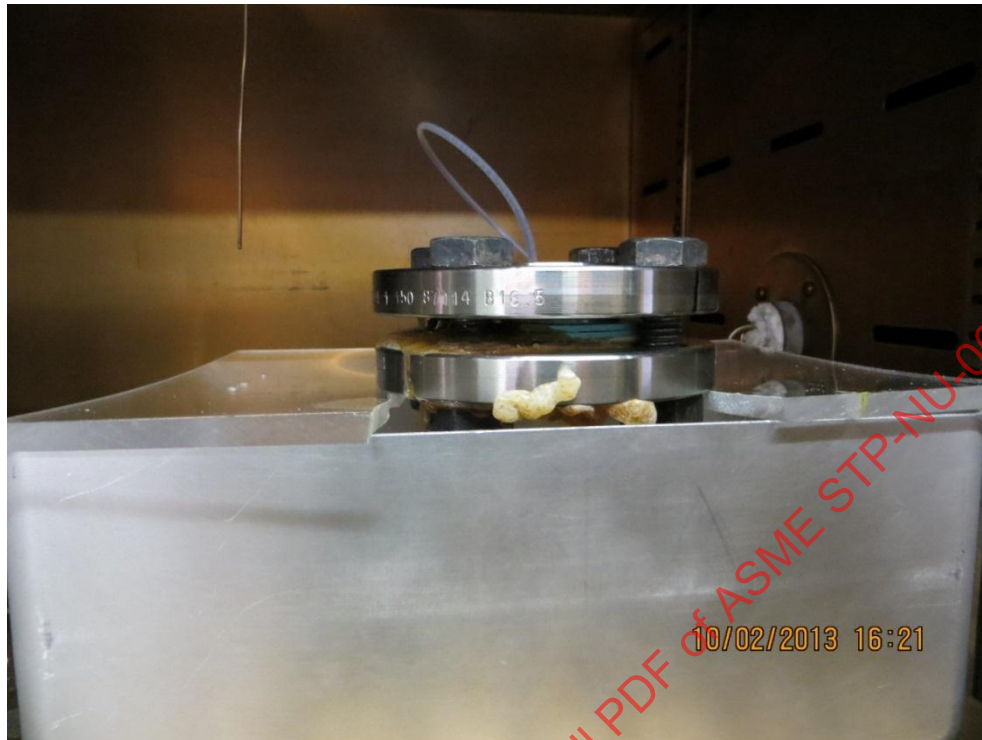
Figure 4-11: Flange #4 after One Week Exposure at 200°F

The orientation of the bolts in Flange 4 is shown in Figure 4-10. A photograph of the flange after one week of exposure is shown in Figure 4-11. Flow was terminated on November 18 at 09:15 after 8 weeks of exposure. Bolts were removed, dried, and weighed. In an attempt to remove the tightly adherent deposits, bolts were placed in individual sealed bags containing dilute (~2%) NaPB solution and suspended in an ultrasonic bath for 35 minutes. Minimal deposit removal occurred during this process, and bolts were allowed to soak in the dilute NaPB solution overnight. Subsequent inspection indicated that deposits still remained tightly adhered to all four bolts. Using demineralized water as a lubricant, a clean nut was used to chase the threads and remove deposits. Bolts were rinsed with demineralized water and allowed to dry under a heat lamp for one hour.
